Sydenham River Fluvial Geomorphology Assessment

Submitted to: Ontario Ministry of Natural Resources and,
St. Clair Region Conservation Authority

Date: December 21, 2000

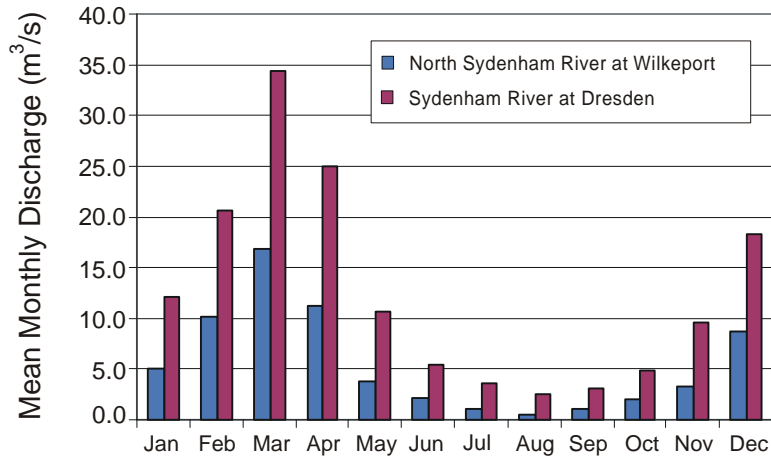
Figure 5. Mean monthly discharges for the North Sydenham River at Wilkeport and the Sydenham River at Dresden (Environment Canada, 1995).

Discharge of the river follows a seasonal pattern, as dictated by precipitation trends across the watershed. According to the flow records for the Sydenham River at Dresden, mean monthly flows attain a maximum of 34.4 m³/s in March then gradually fall to around 2.52 m³/s during August (Figure 5). A similar trend was observed in the North Sydenham/Bear Creek System at Wilkesport, also with a maximum in March (16.9 m³/s) and minimum in August (0.559 m³/s).

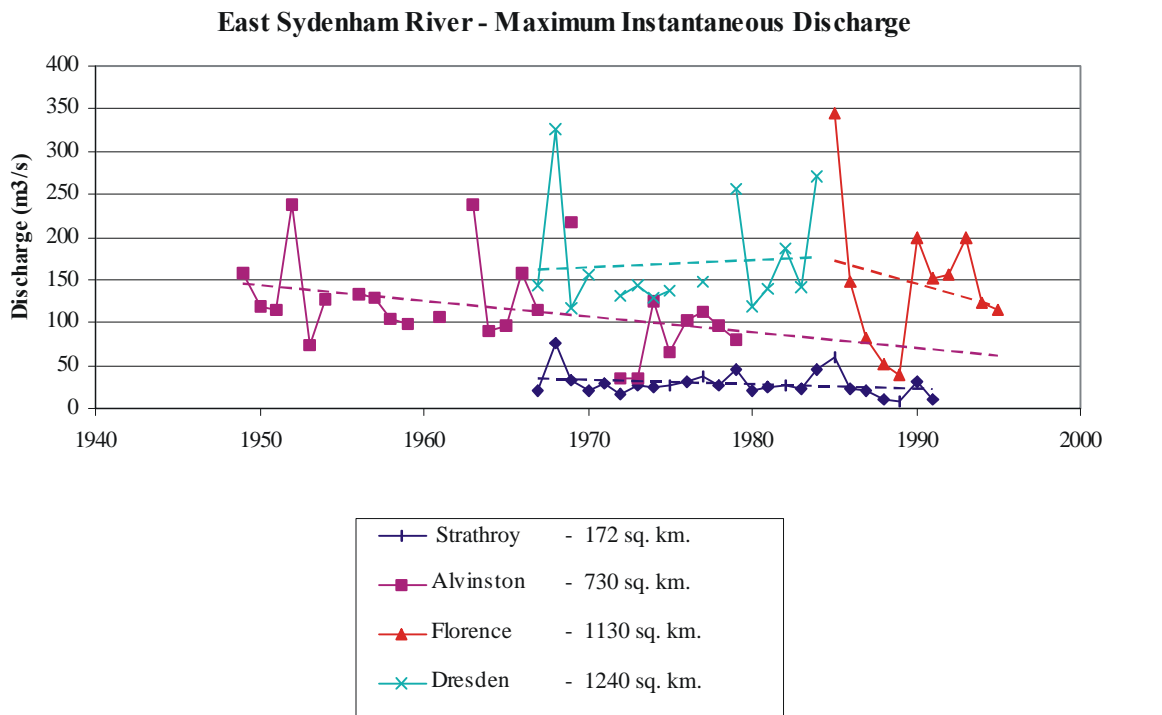
Figure 7. Mean annual flow and Maximum instantaneous discharge for four gauging stations along the Sydenham River. (Environment Canada, 1995)

flows was observed at all records except Dresden, although the data record here is limited to only 15 observations. In the East Sydenham at Strathroy and Alvinston, where the data record is longest (25 years), peak flows have been reduced by 20-30%. A similar reduction was found in Bear Creek at all three gauging stations. While the flow regime is changing, it was greatly altered by land use change that occurred in the 1800's. Both flow volumes and peak flows would have increased. While peak flows are decreasing, the values are likely higher than levels prior to European settlement of the region.

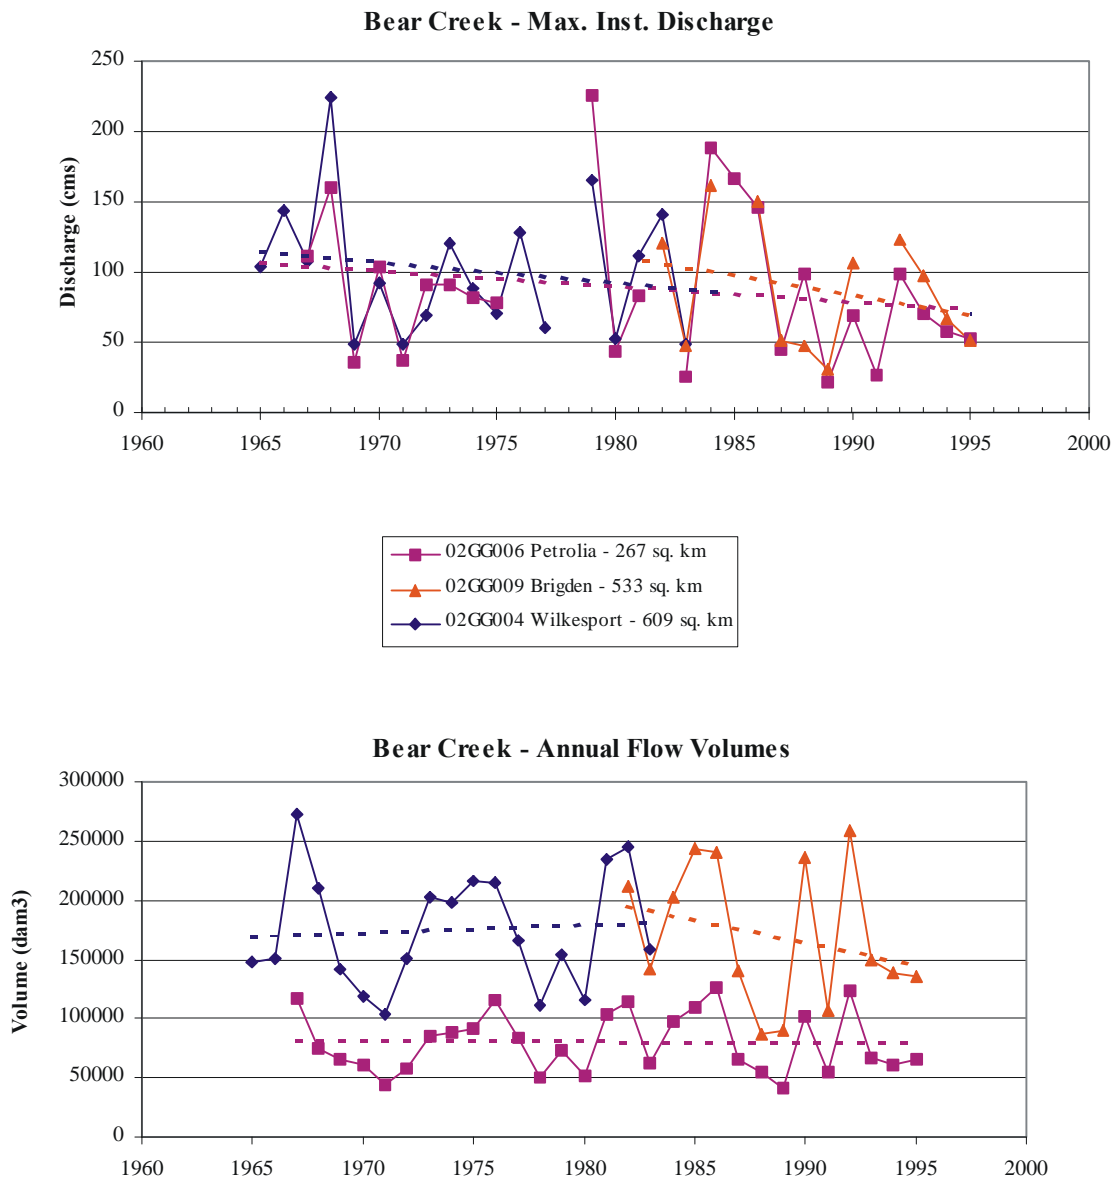
Figure 8. Mean annual flow volume and maximum instantaneous discharge for 3 stations along Bear Creek (Environment Canada, 1995).

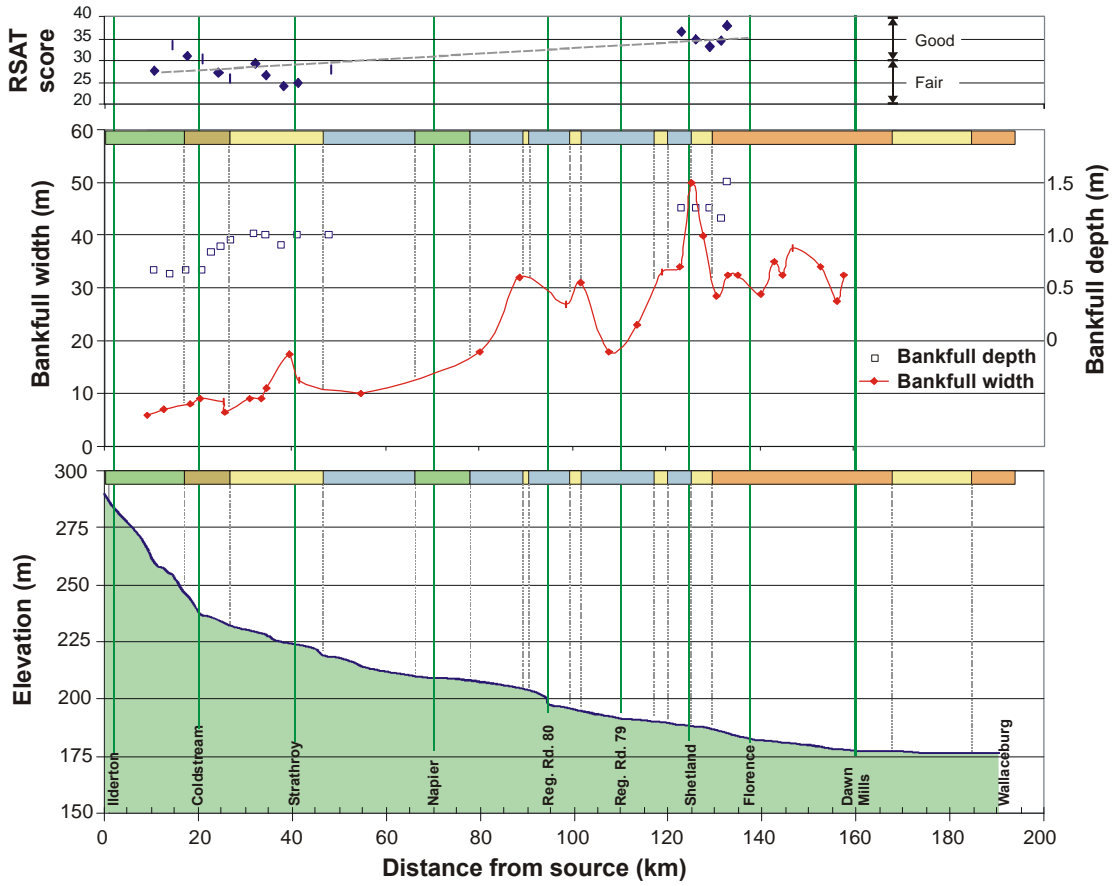
Figure 14. Relationship between gradient, bankfull width and depth and RSAT scores along the East Sydenham River.

Figure 14 illustrates the physical aspects of the East Sydehnam basin (geology, gradient, channel dimensions). Gradients were steepest (0.25%) in the upper 20 kilometres of the watershed. Below Coldstream, gradient drops and remains constant at approximately 0.05%. A notable knickpoint is located near Alvinston where the channel has cut into bedrock. Below Dawn Mills, the gradient is essentially flat and backwater conditions prevail. As expected, channel widths increase in the downstream direction. Geological material varies considerably along the river with numerous crossings of sandy facies. Substantial increases in width appear to correspond to the occurrence of sandy deposits. Outcrops of shale were also observed along the channel boundary (Staton *et al*, 2000) and were observed during the field reconnaissance between Shetland and Florence. In some areas, bankfull widths exceeded 100 metres and large mid-channel bars have formed. Vegetation has colonized the bar deposits in the form of grasses, tall herbs and shrubs. The bars shown on the 1969 topographic maps were present in 2000 and have not migrated downstream. The bars appear to have formed when peak flows were higher or when there was abundant sediment supply.

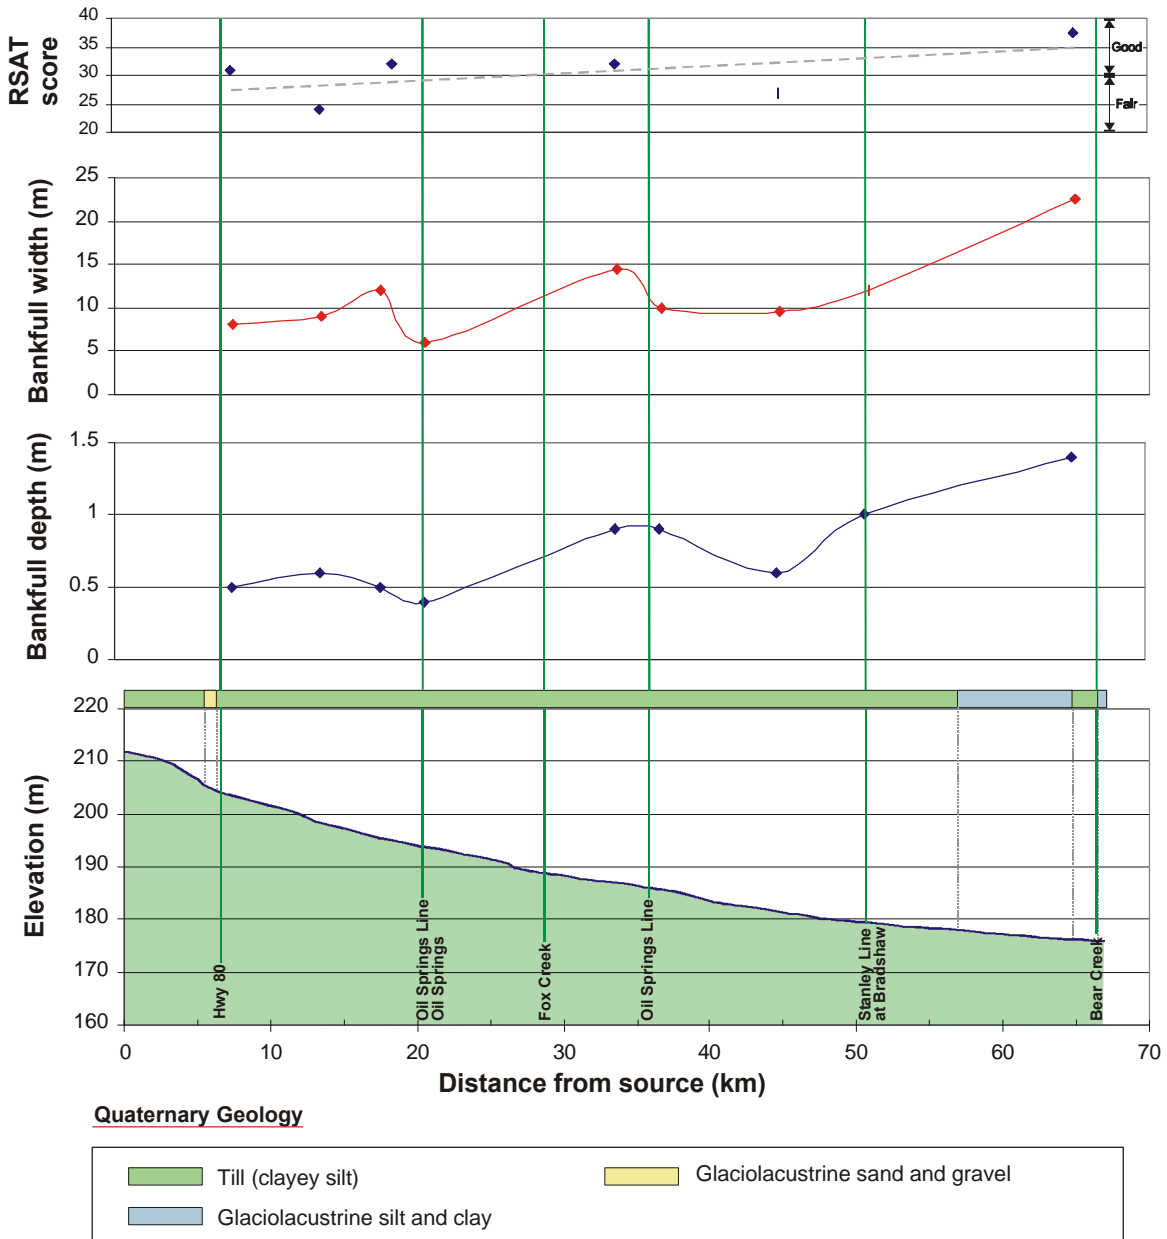
Figure 17. Relationship between gradient, bankfull width and depth and RSAT scores along Black Creek.

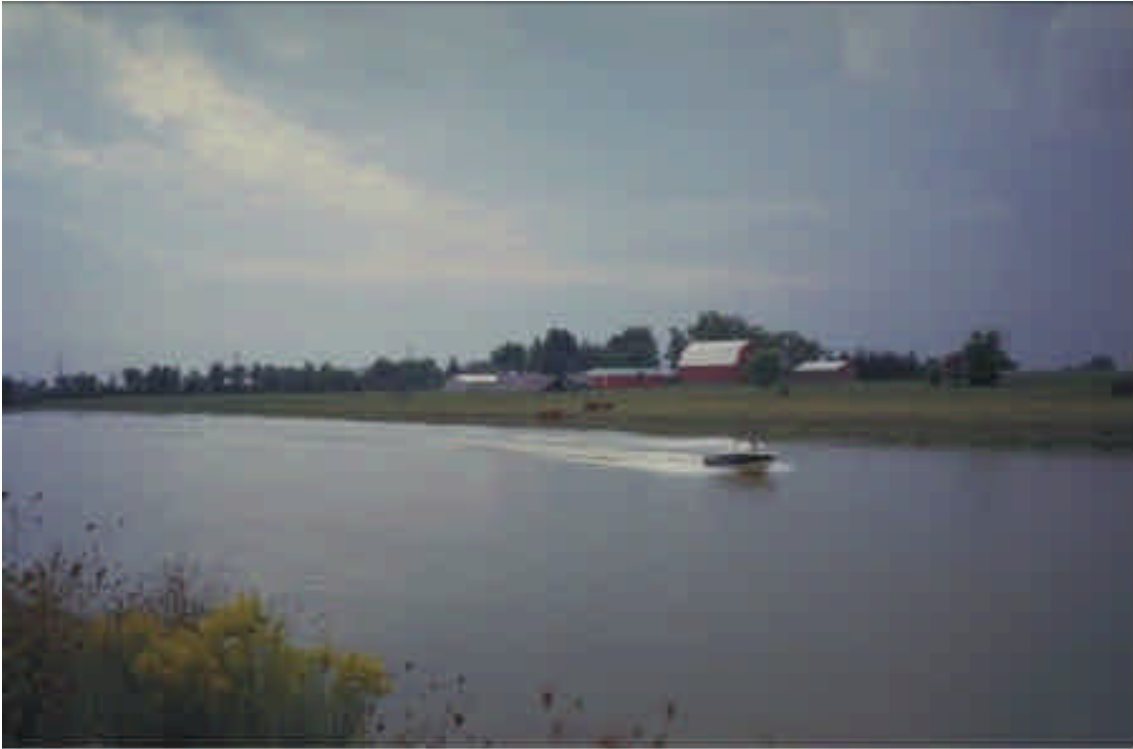
Photo 1. *North Sydenham, Reach NS-1.* The channel is wide and deep with no apparent morphological structure. The wakes from boat traffic have historically contributed to bank erosion at this location.

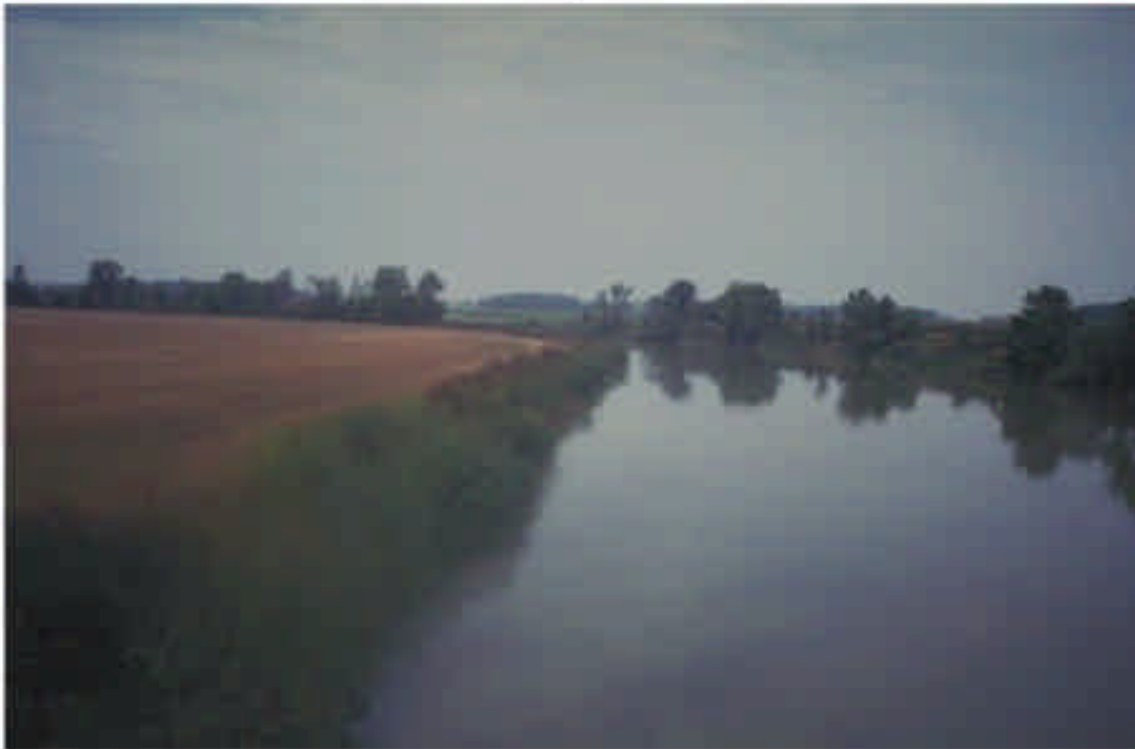
Photo 2. *Reach NS-2.* This reach is characterized by its wide channel width and very narrow riparian zone.

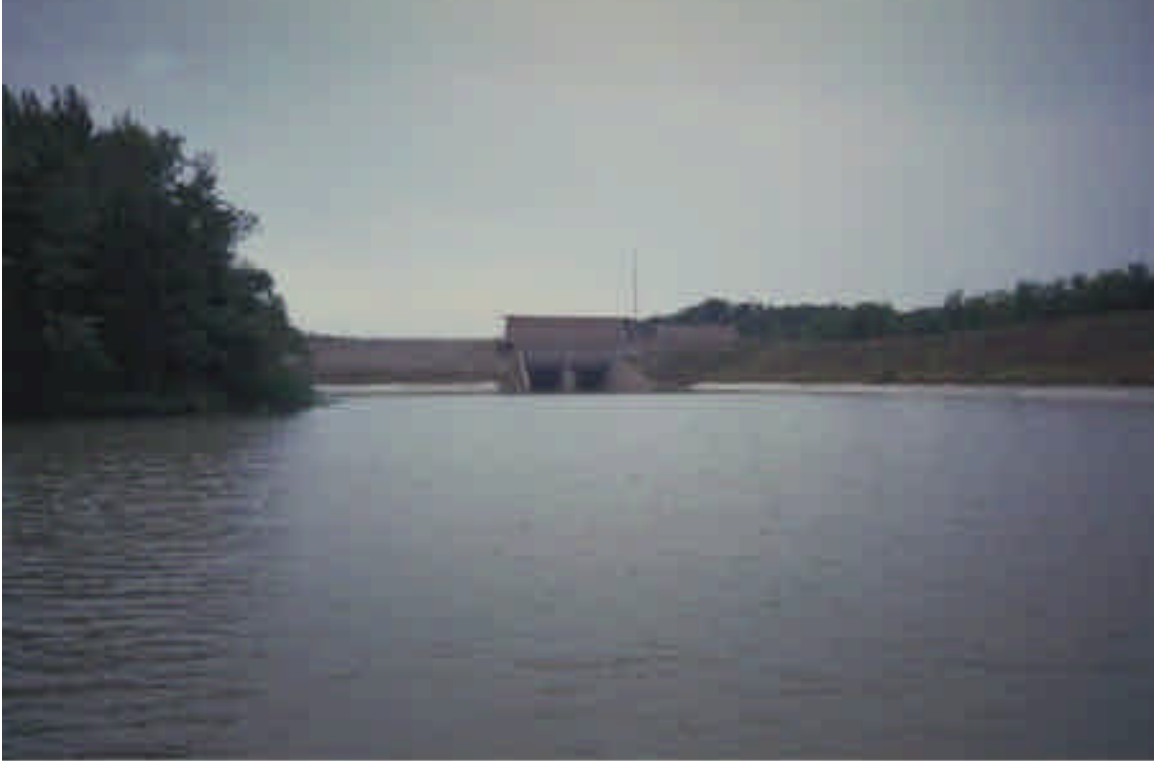
Photo 3. *Reach NS-3.* The Darcy McKeough Dam has influence on this reach. At the time of survey the floodgates were open.

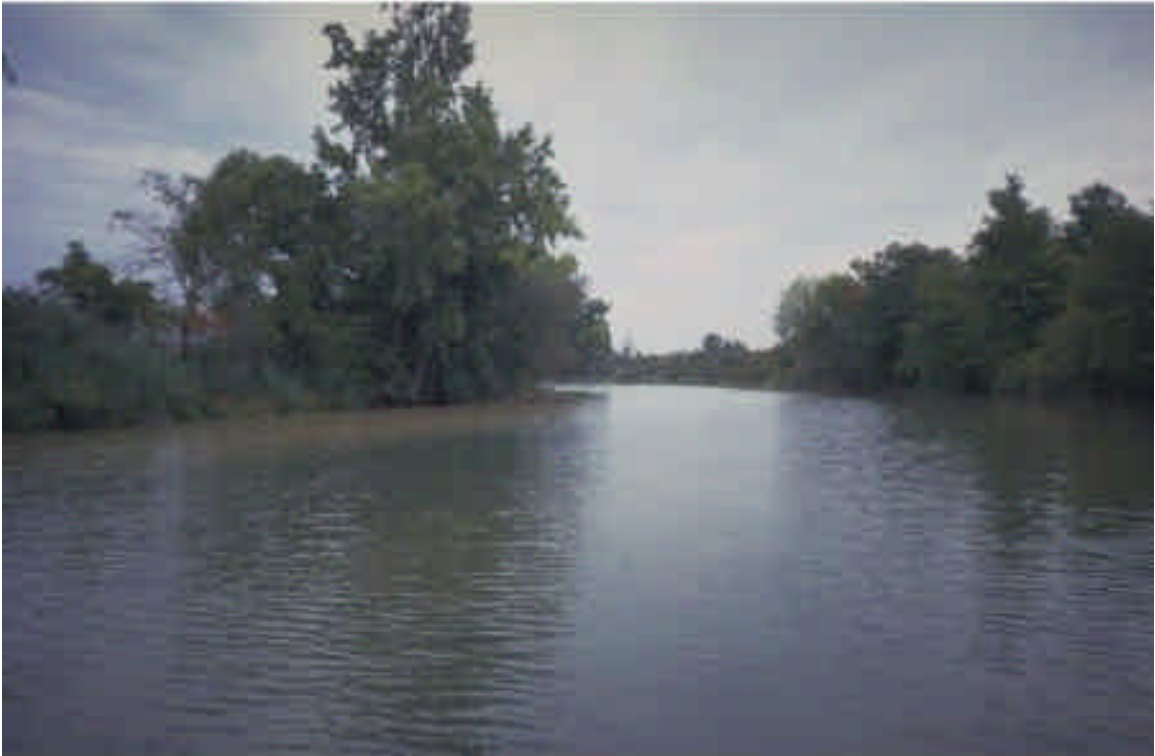
Photo 4. *Reach NS-4.* A typically wide reach, with little bed morphology. At the time of the survey many large algae blooms were present in the channel causing large patches of "green water".

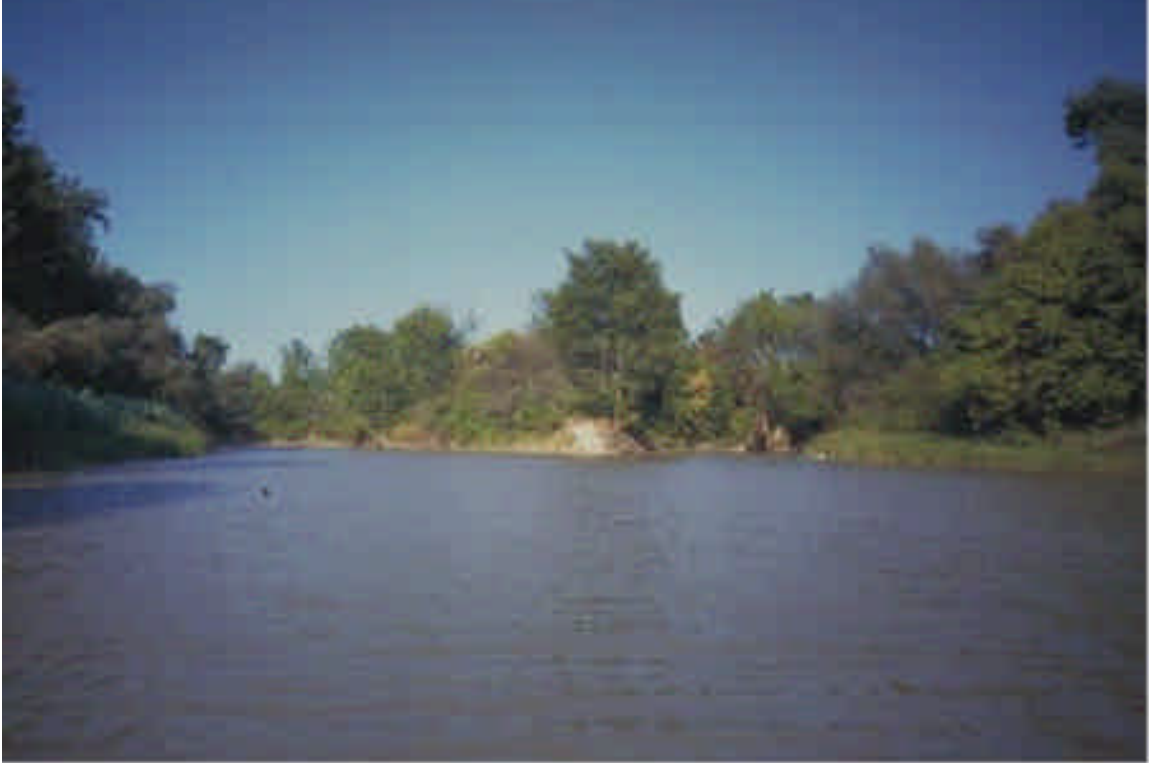
Photo 5. Confluence of Bear Creek (left) and Black Creek (right) where they become the North Sydenham River. Note the erosion occurring at the confluence.

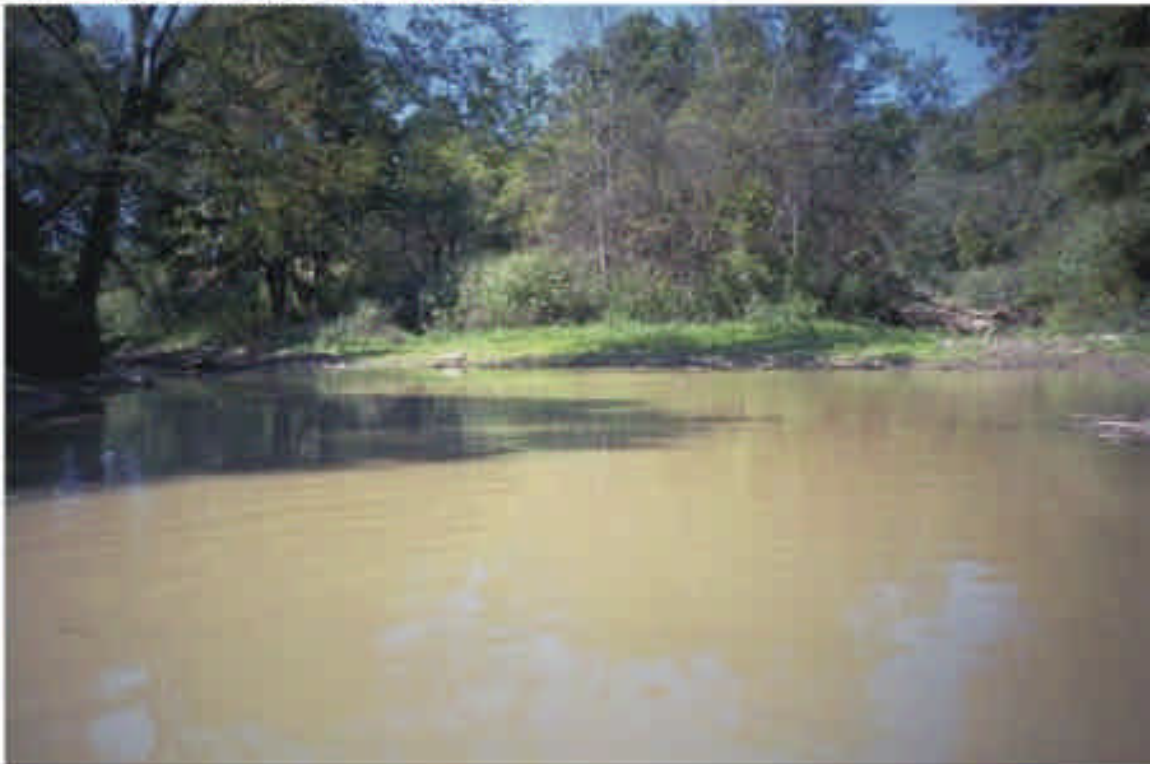
Photo 6. Reach BEAR 3. This reach has many areas of erosion and a large amount of wood debris. Note the meander cut-off, which is occurring at the right of the photo.

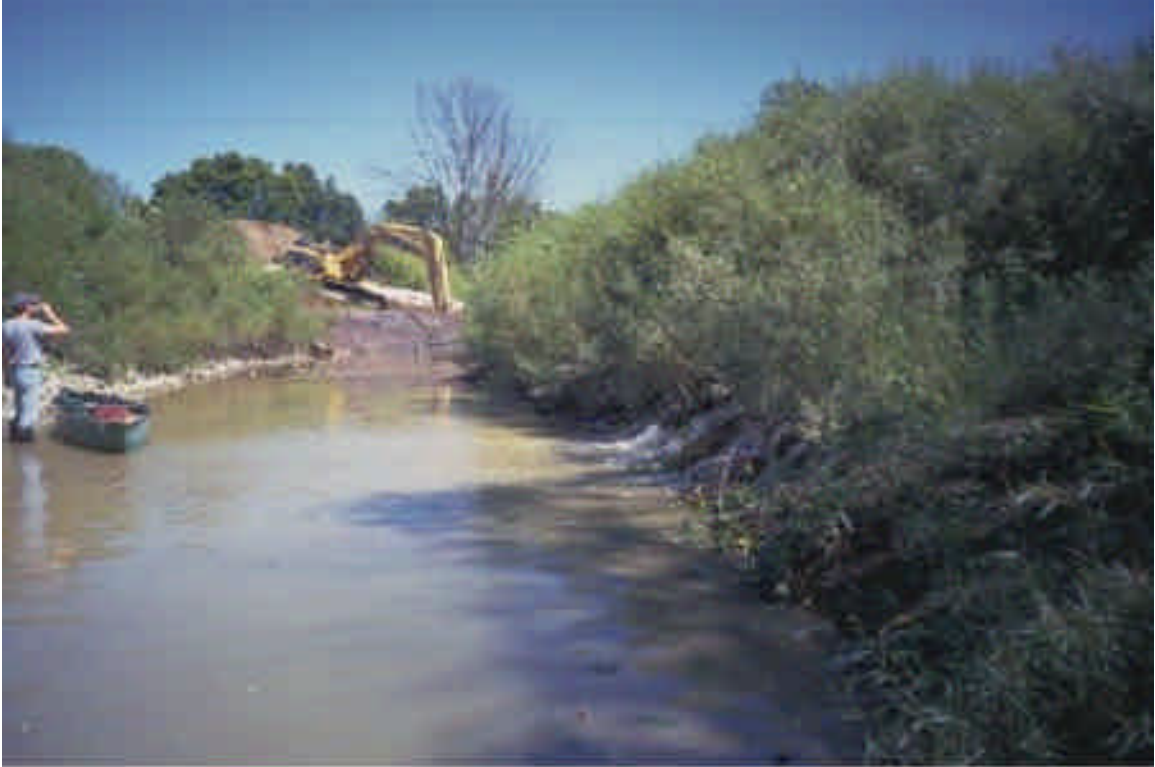
Photo 7. *Reach BEAR 4.* Pipeline construction has blocked the channel and the flow is being pumped around the site and down the bank (center).

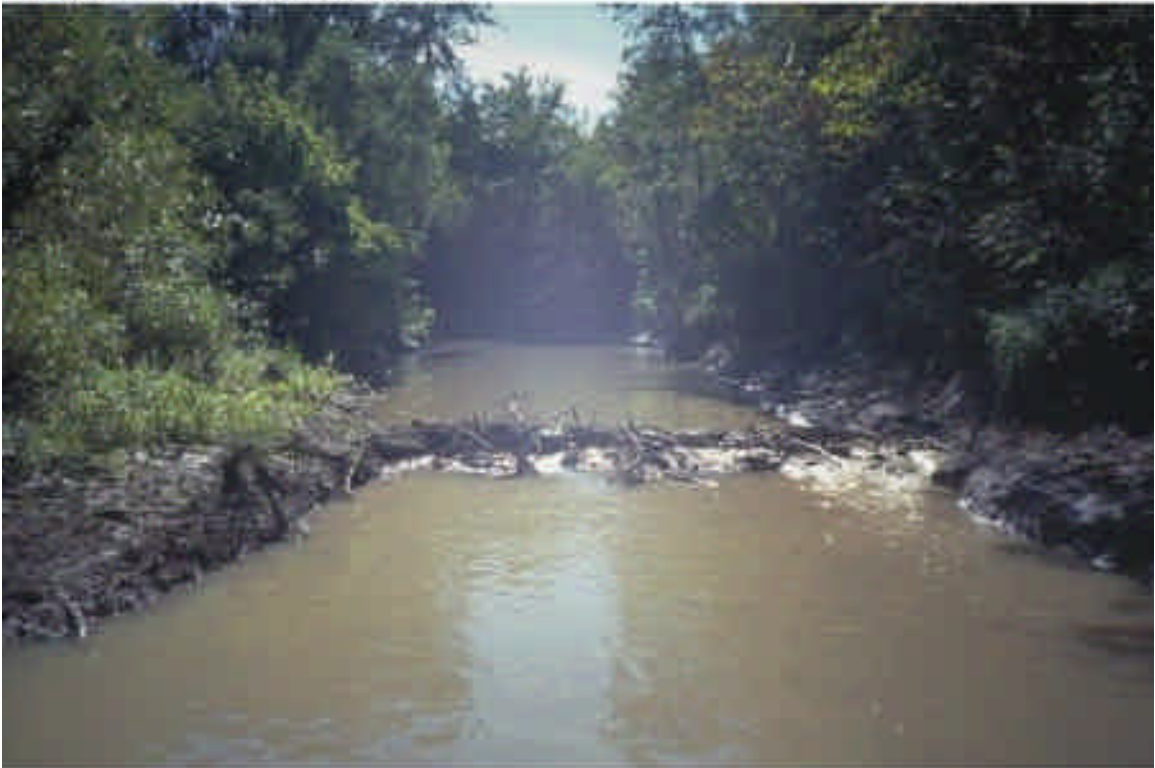
Photo 8. *Reach BEAR 6.* This reach is well vegetated which has allowed significant beaver activity to occur as indicated by several beaver dams.

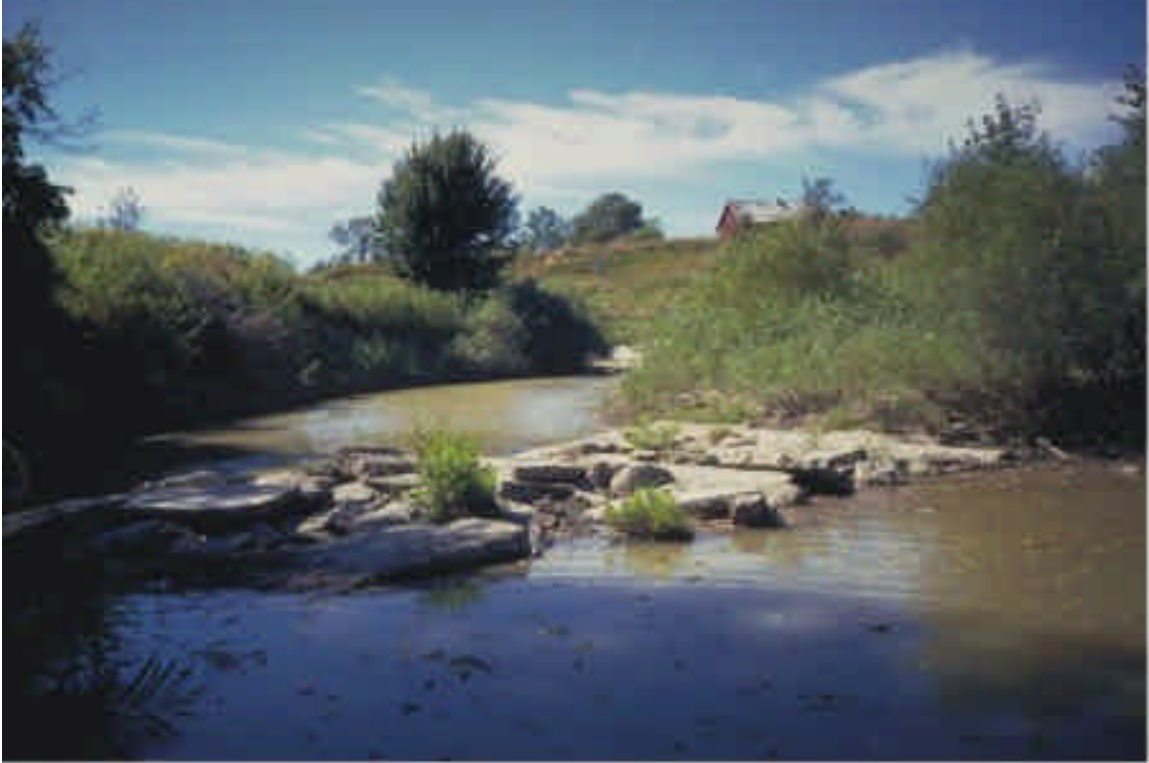
Photo 9. *Reach BEAR 10.* An abandoned crossing is creating a large backwater area. The channel has begun to circumvent the crossing by eroding away the left bank.

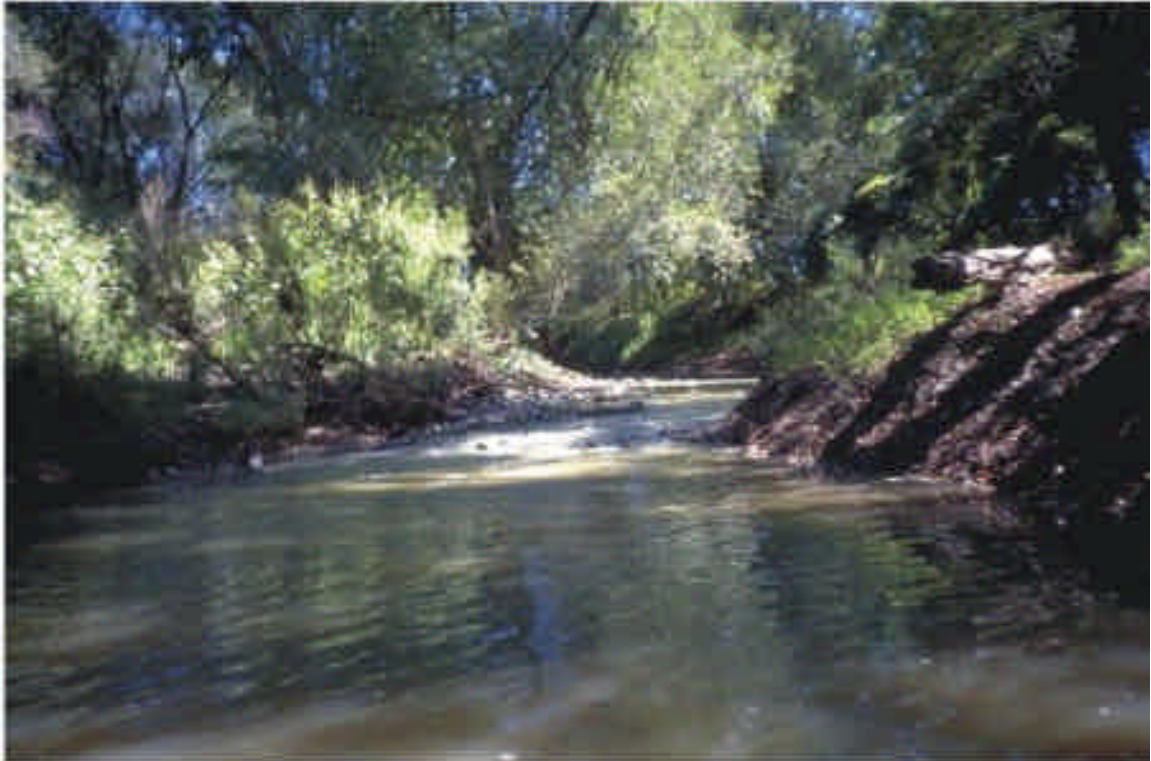
Photo 10. *Reach BEAR 11.* This lower portion of this reach has well defined bed morphology as displayed by the above riffle. The riffles tended to be coarser indicating an increase in local gradient.

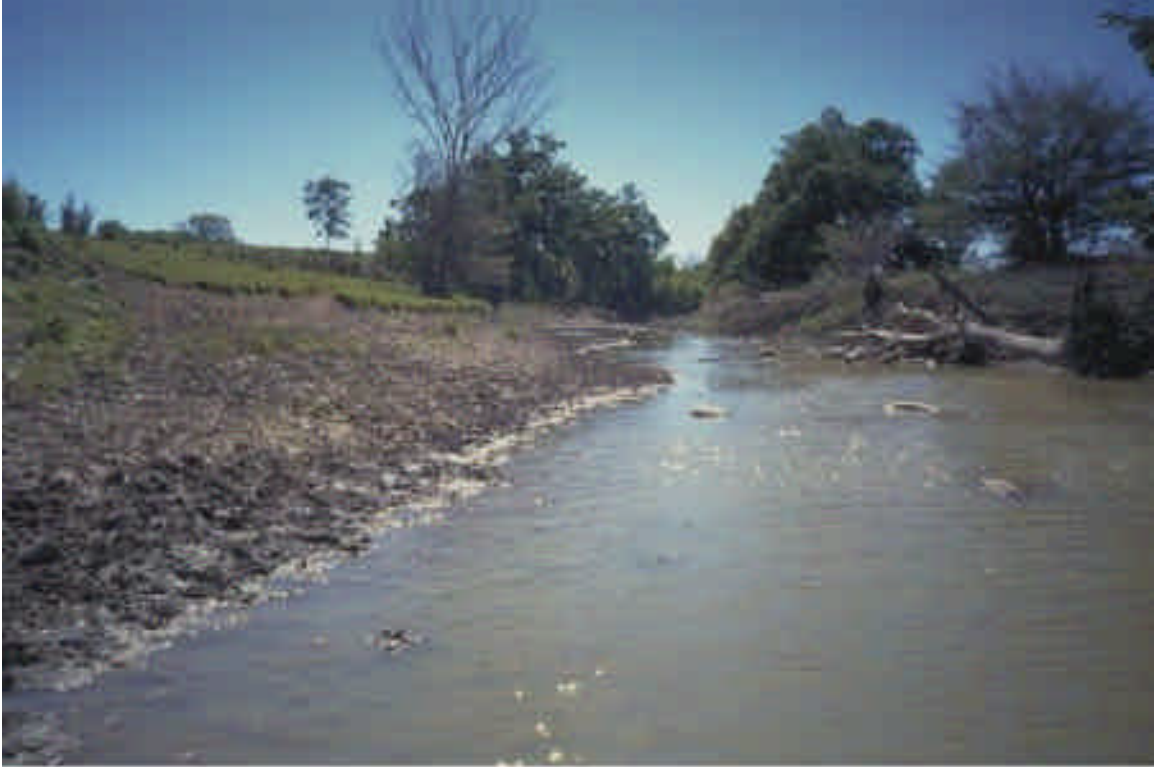
Photo 11. *Reach BEAR 11.* This photo typifies the effect of cattle access to the channel. The banks tend to be grazed bare and cattle movement up and down the banks exacerbates erosion.

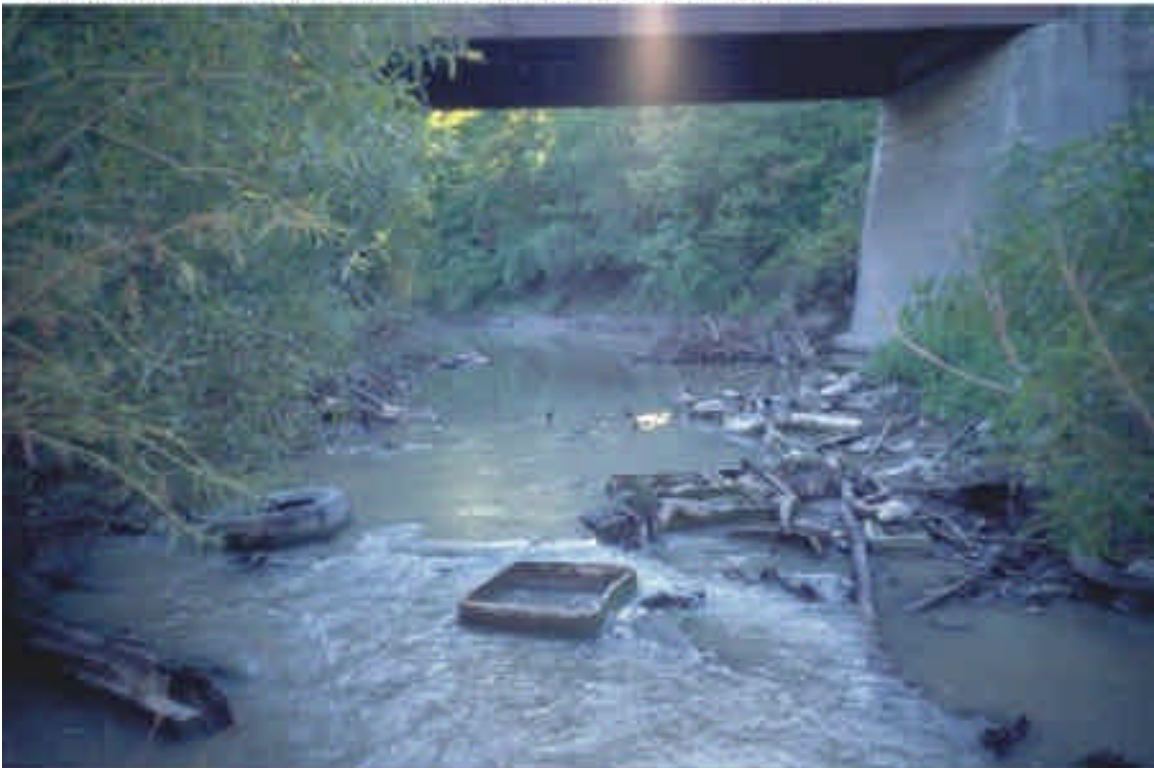
Photo 12. *Reach BEAR 14.* Considerable garbage was observed in Bear Creek. The bridge in this photo was used to dump garbage.

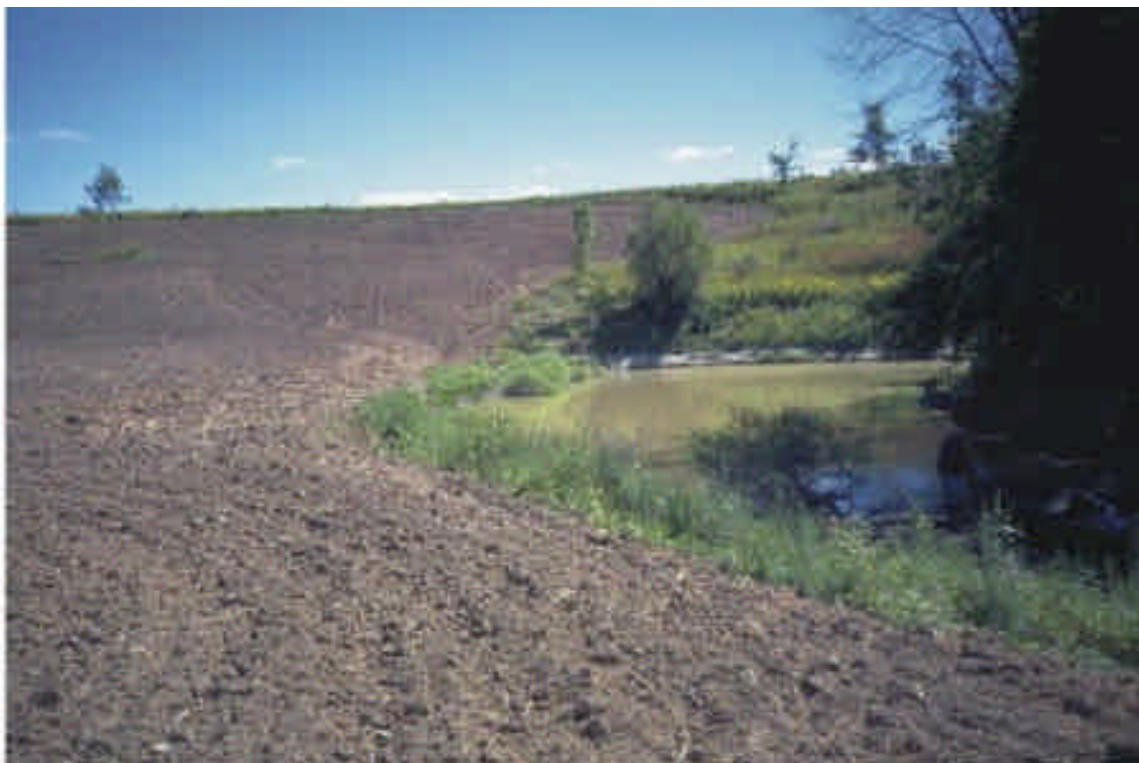
Photo 13. *Reach BEAR 17.* A portion of this reach has experienced recent floodplain clearing and cultivation to the stream margin.

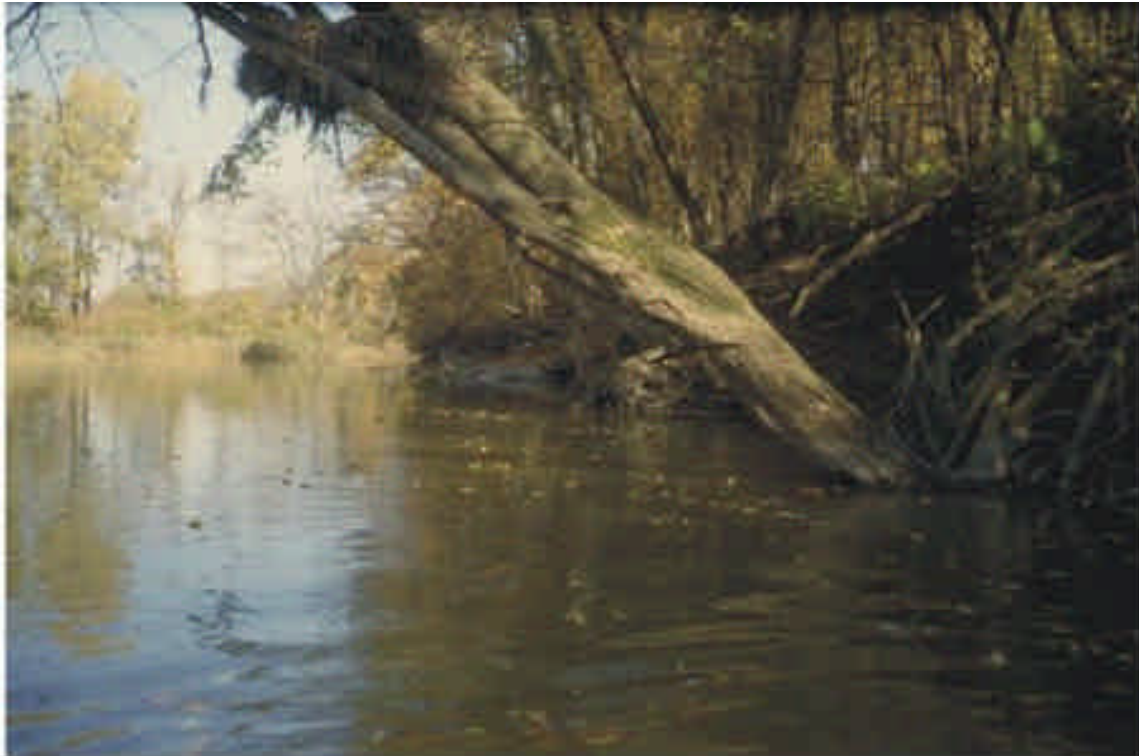
Photo 15. *Reach SR 14.* Banks tend to be somewhat eroded with some leaning or fallen trees. Note that in the tree (top right) indicating the level of recent high flows.

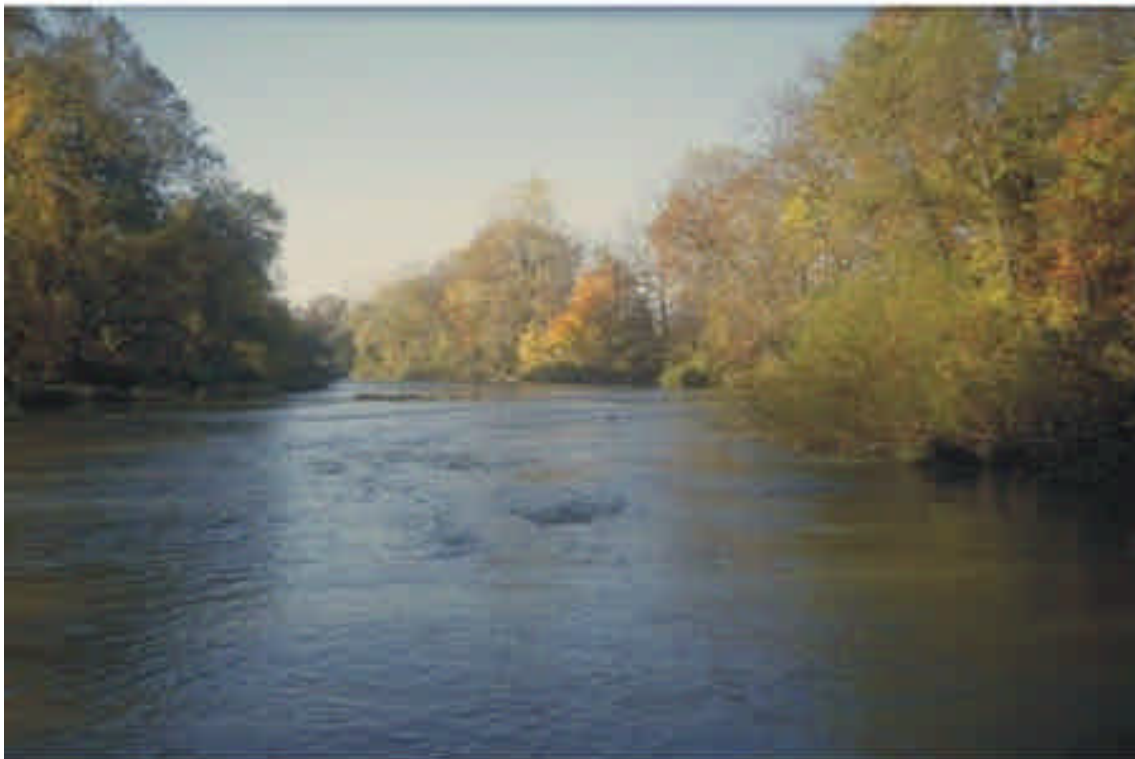
Photo 16. *Reach SR 16.* Well-defined pool-riffle sequences, bedrock substrate and dense bank vegetation define this reach.

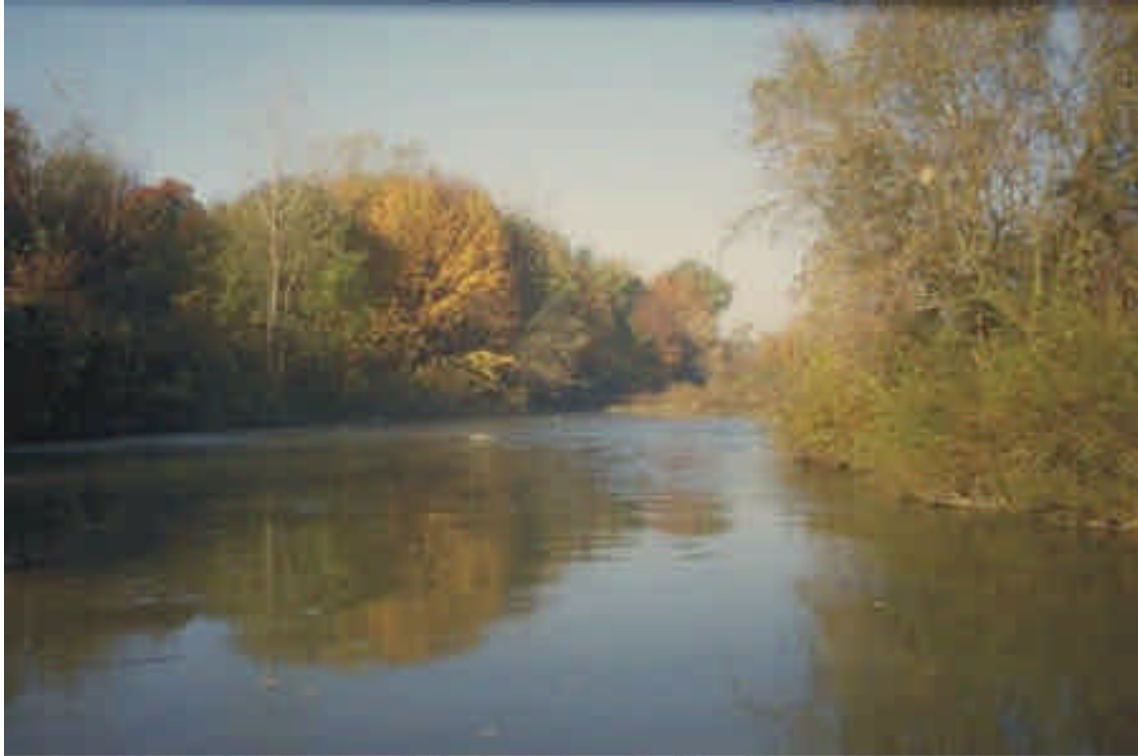
Photo 17. *Reach SR 17.* Several islands are located within this reach. Bedrock dominated pool substrate whereas coarse gravel and cobble was found in riffles.

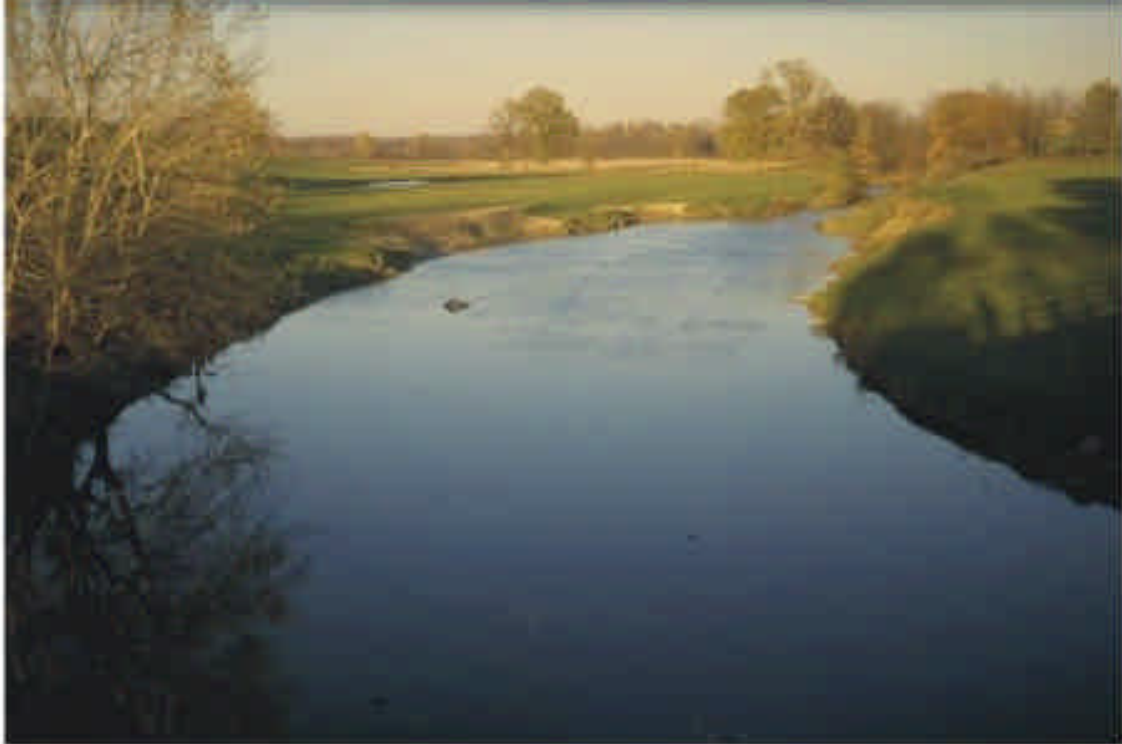
Photo 19. *Reach SR 33.* The bridge crossing and livestock activity have caused a local increase in channel width. Note narrower stream 100 m upstream of bridge (top right)

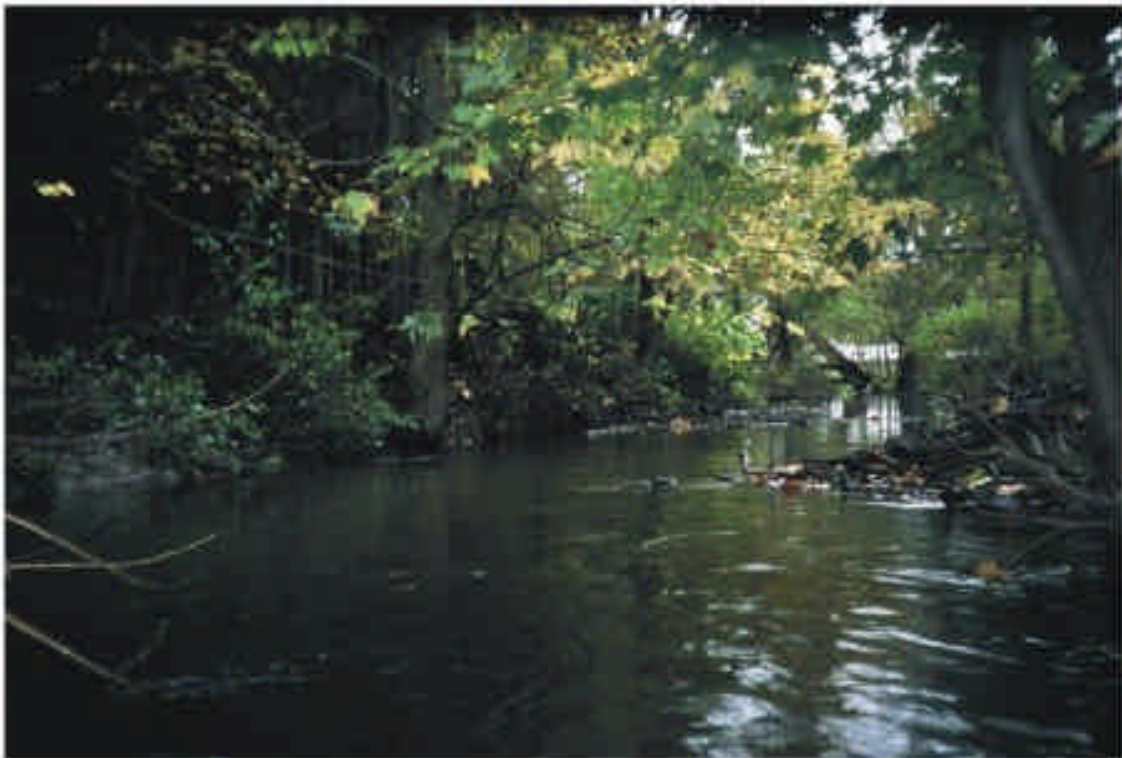
Photo 20. *Reach SR 41.* Forested portions of this reach contribute significant amounts of wood debris to the channel. Flows were approximately 60-80% of bankfull.

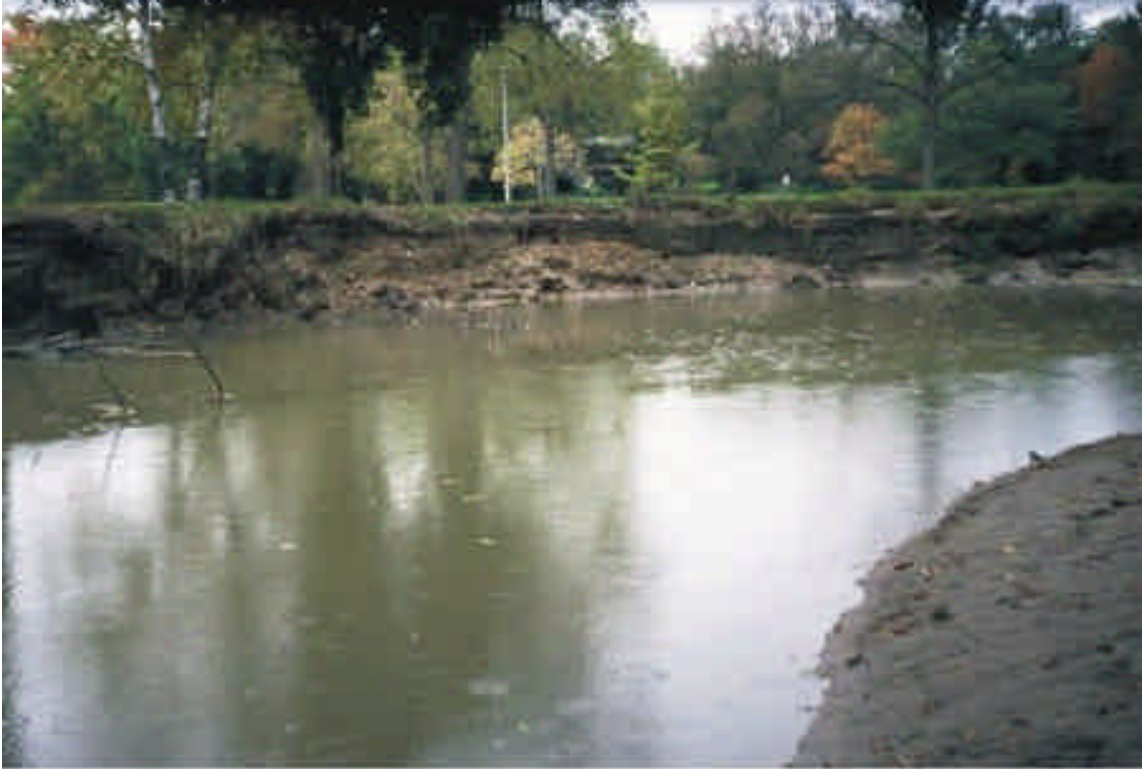
Photo 21. *Reach SR 45.* Park area downstream of Strathroy. Sandy soils increase the sensitivity of the banks to erosion. Vegetation has been mowed to the bank (above) which has contributed to increased bank erosion at this site.
