Sydenham River Fluvial Geomorphology Assessment

Submitted to: Ontario Ministry of Natural Resources and,
St. Clair Region Conservation Authority

Date: December 21, 2000

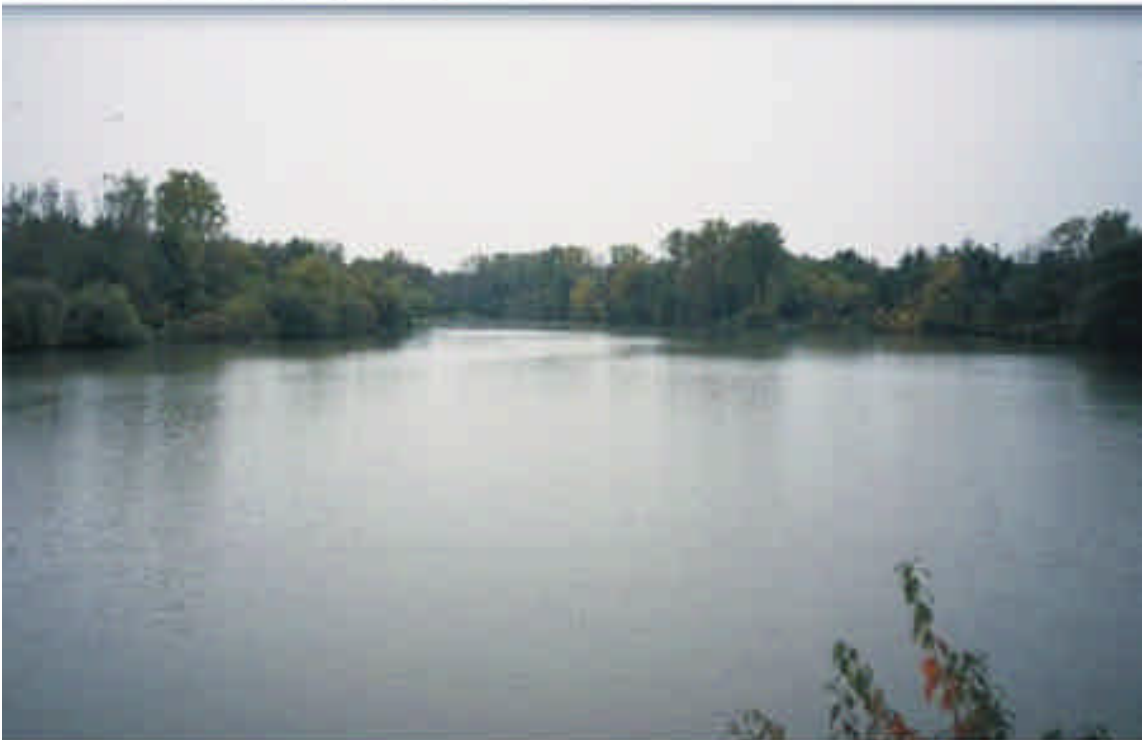
Photo 22. *Reach SR 45.* Reservoir upstream of dam in Strathroy. Siltation is an ongoing process in this area.

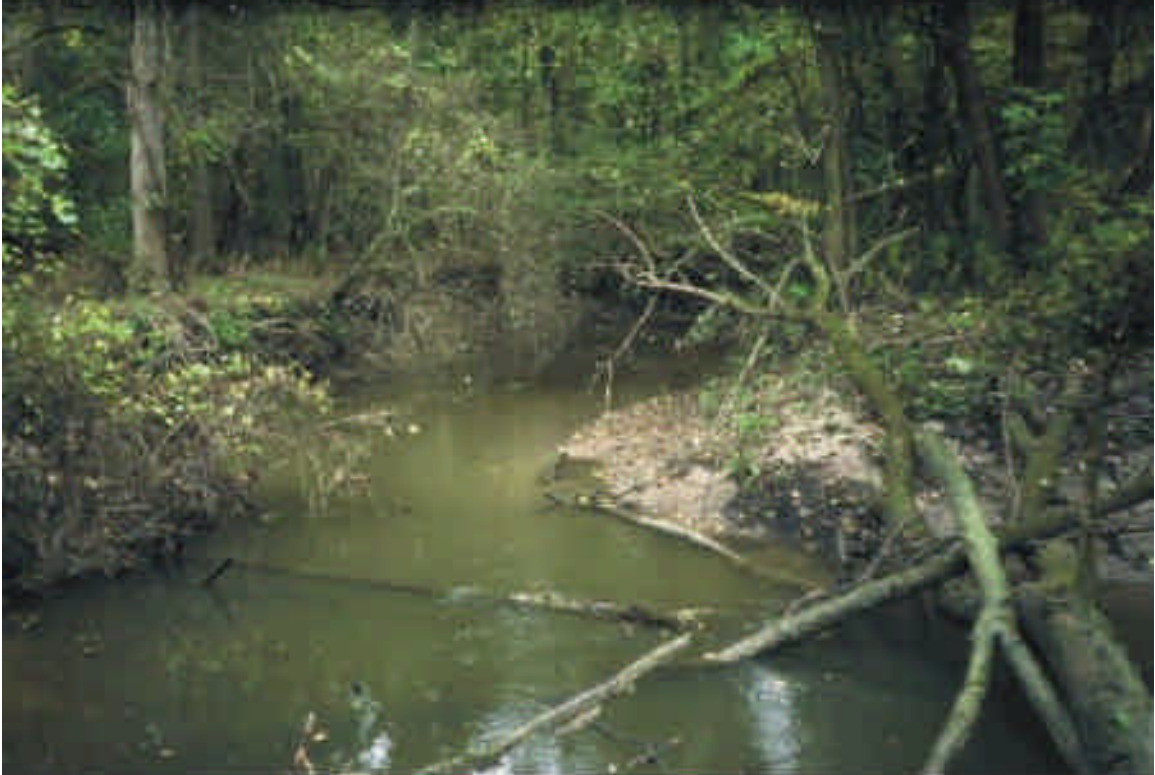
Photo 23. *Reach SR 47.* Midway between Coldstream and Strathroy. The channel flows across lacustrine clay plain and is narrow and deep with significant woody debris.

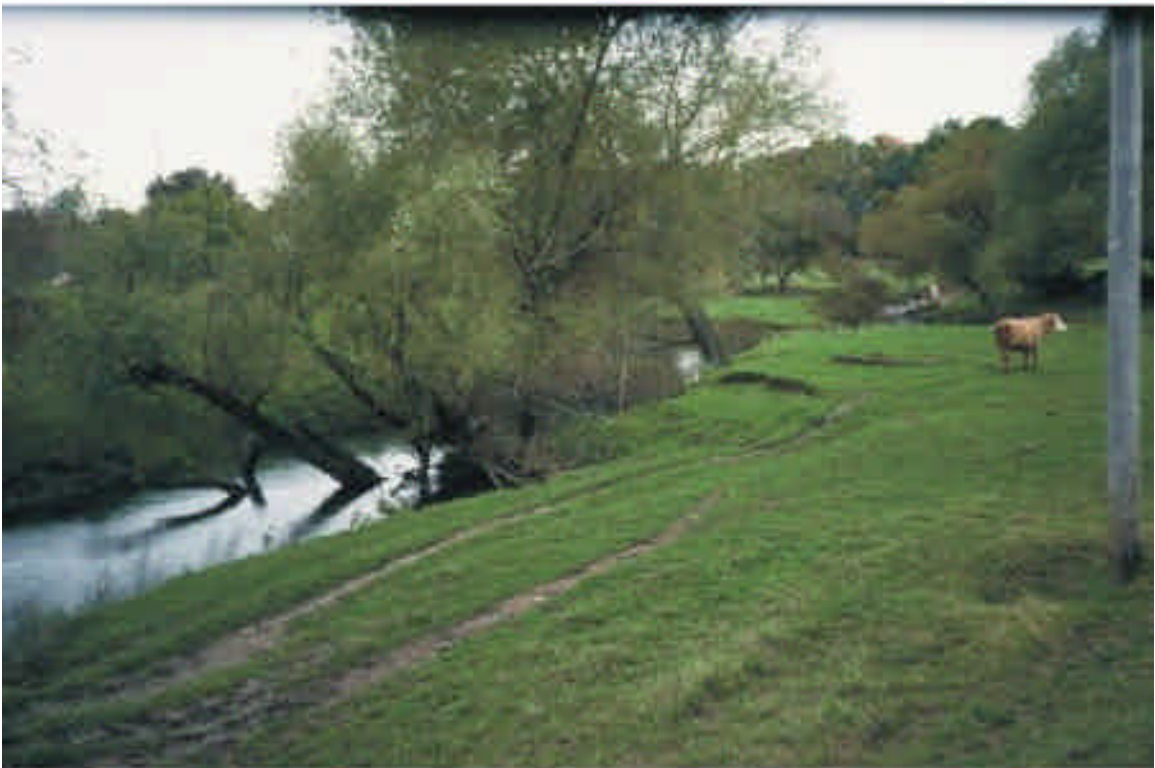
Photo 24. *Reach SR 50.* Portions of this reach have been affected livestock grazing. Many banks exhibit signs of erosion and degradation.

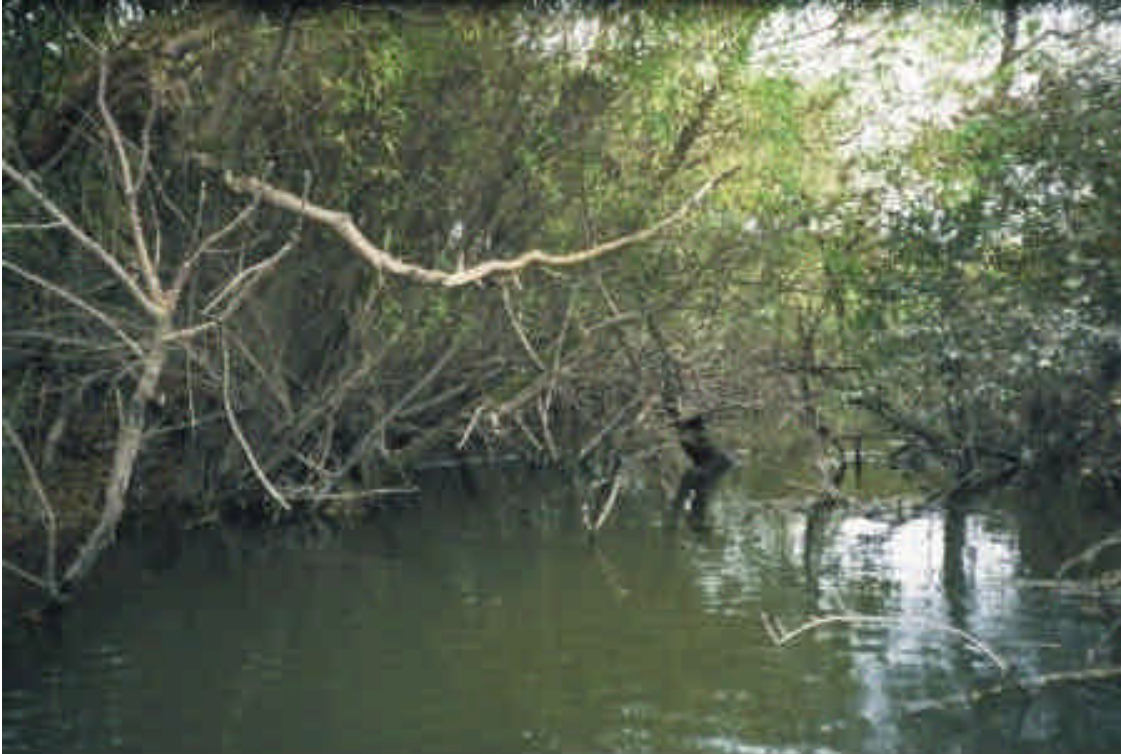
Photo 25. *Reach SR 51.* This relatively narrow but deep reach has large amounts of woody debris within the wetted part of the channel .

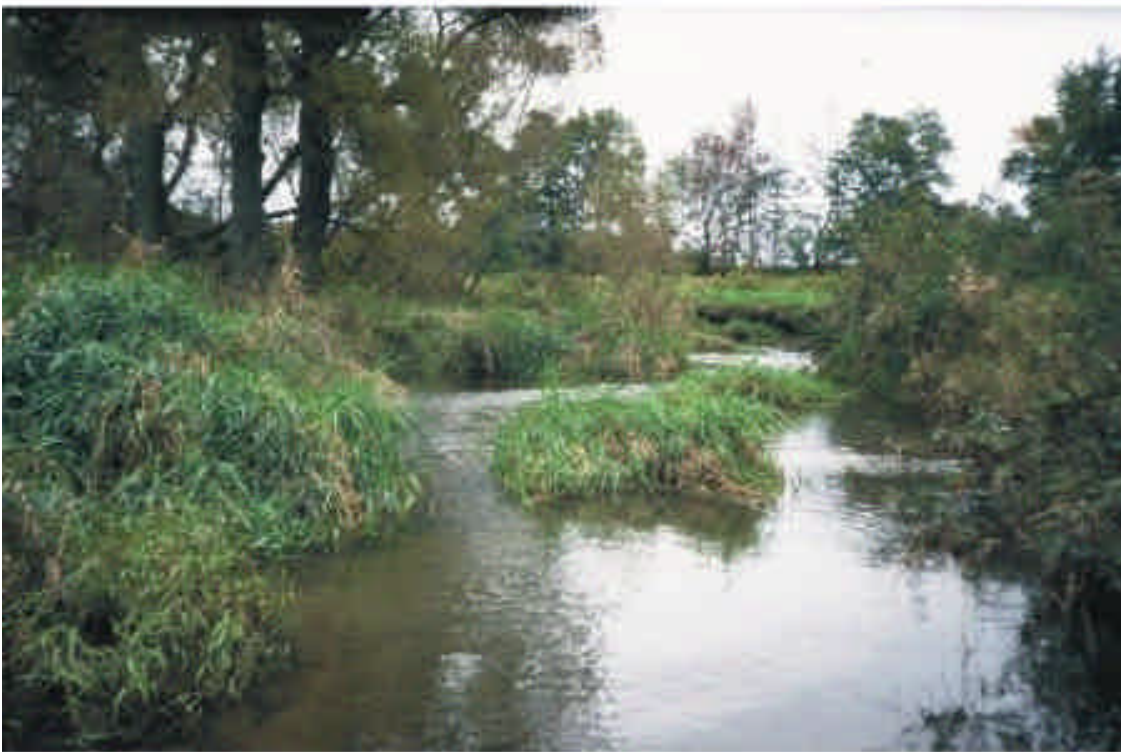
Photo 26. *Reach SR 55.* Bank erosion and relatively high sediment loads were predominant in this portion of the watercourse, as illustrated by the bar deposits and undercut banks. View upstream.
